# **2019 Remedial Action Annual Effectiveness Report**

## **Alcoa (Point Comfort)/Lavaca Bay Superfund Site**

**March 2020**

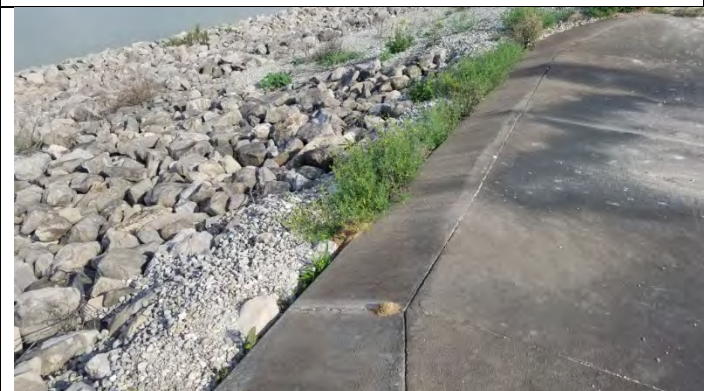
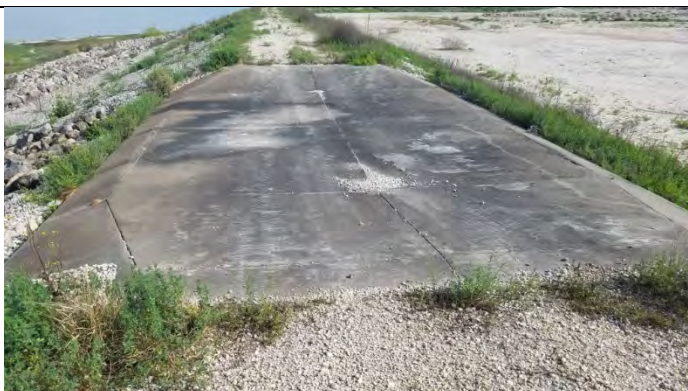
<p>29 – Emergency Spillway, viewing minor erosion along the outer edge</p>	<p>30 – Emergency Spillway, viewing minor deterioration of the concrete and surrounding vegetation</p>

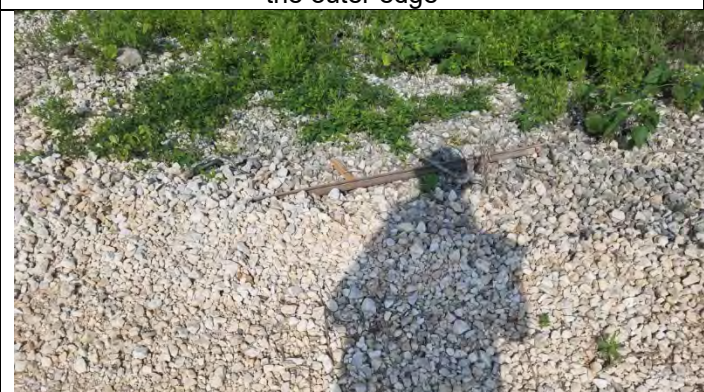
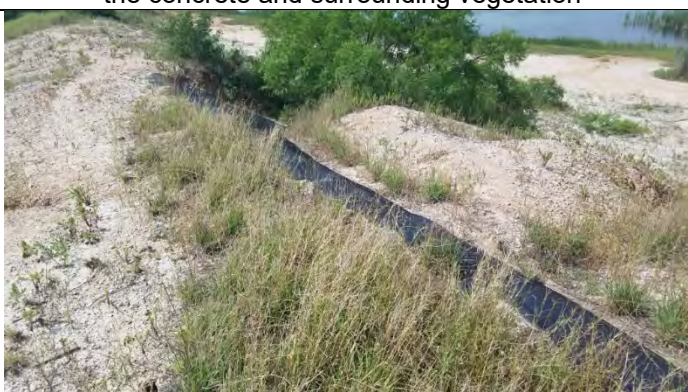
<p>31 – East Outer Dike, viewing damaged sign</p>	<p>32 – East CPA Inner Dike, viewing erosion and exposure of liner</p>

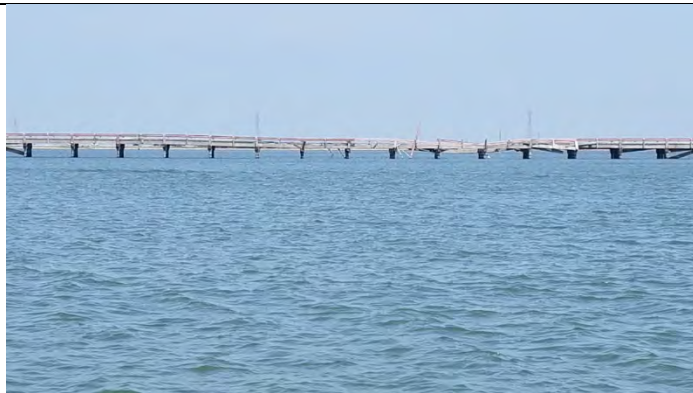
35 – Dredge Island Access Bridge, viewing damage

The access bridge was damaged during Hurricane Claudette in 2003 and again during Hurricane Harvey in 2017. Dredge Island inspections have not included detailed inspections of the bridge as it is non-operational and not relevant to the RAOs. However, Alcoa continues to maintain signage and navigational lighting to prevent access to, and collision with, the remaining portions of the bridge.

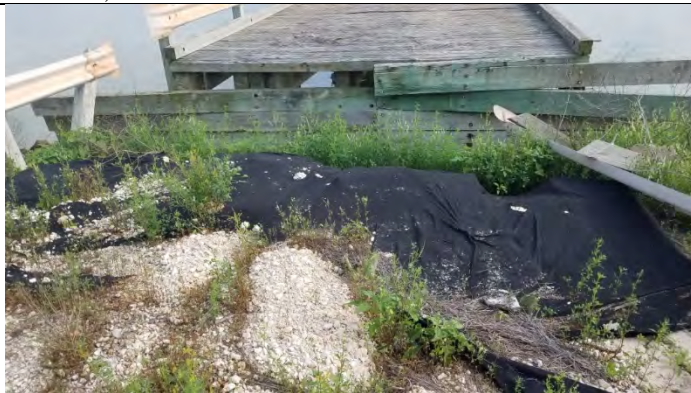
36 – Dredge Island Access Bridge, viewing erosion between the bridge and the island

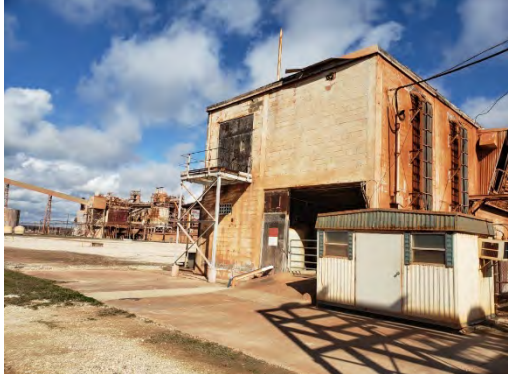
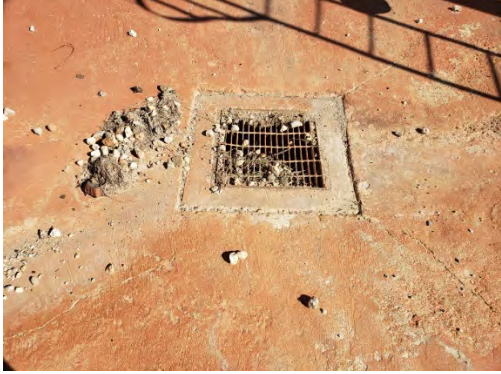
1 – R301, showing damaged roof on western exterior	2 – R301, storm sewer drain

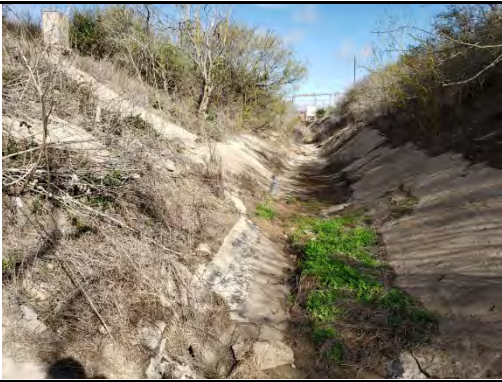
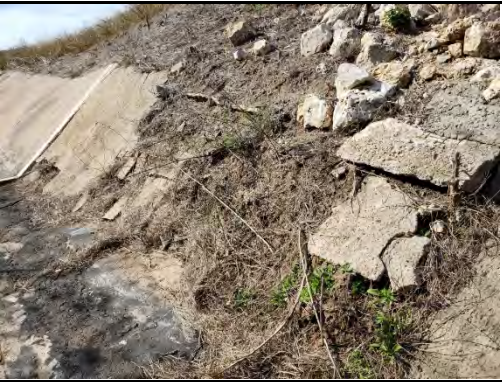
9 – Drainage channel, West end of old channel, viewing East	10 – Drainage channel, viewing deterioration of old channel

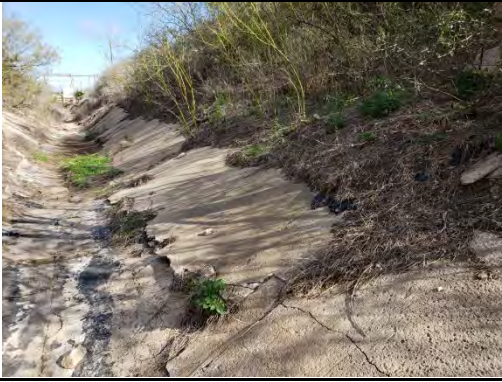
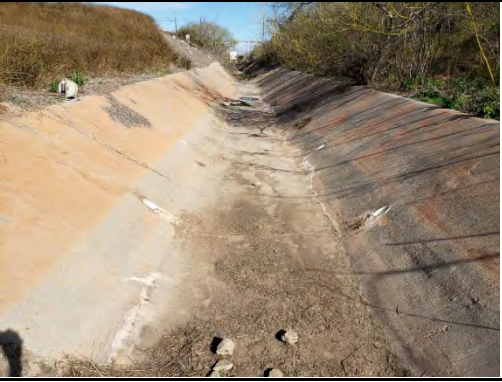
11 – Drainage channel, viewing deterioration of old channel	12 – Drainage channel, West end of new channel, viewing East

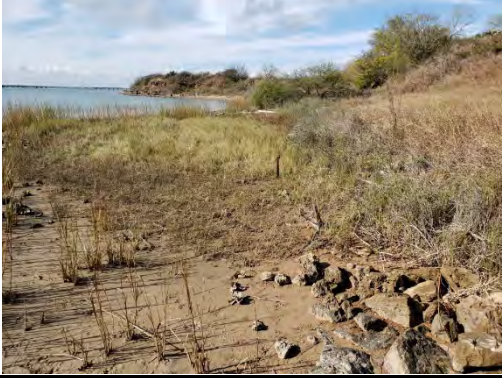
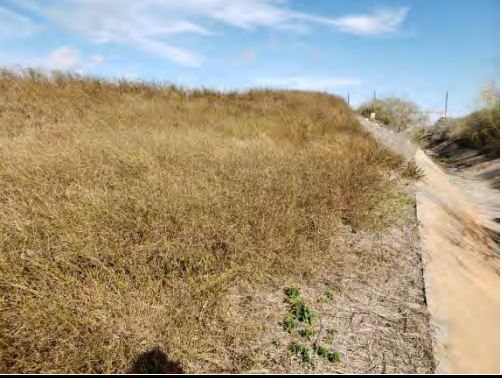
15 – Slope from cap to channel, viewing deteriorated silt fence	16 – Slope from cap to channel, viewing slope
